14 THE SOURCE HOTEL, LLC, a
15 California limited liability company,

19 **DECLARATION OF ROBERT "CHARLIE"**
20 **CERVANTES IN SUPPORT OF**
21 **OPPOSITION TO NOTICE OF MOTION**
22 **AND MOTION FOR RELIEF FROM THE**
23 **AUTOMATIC STAY UNDER 11 U.S.C. §**
24 **363 (REAL PROPERTY)**

7 5. On March 25, 2021, I conducted a thorough walk-through of the Hotel to personally assess the maintenance issues raised by Shady Bird in the Motion and to take photos of the Hotel, which are included below.

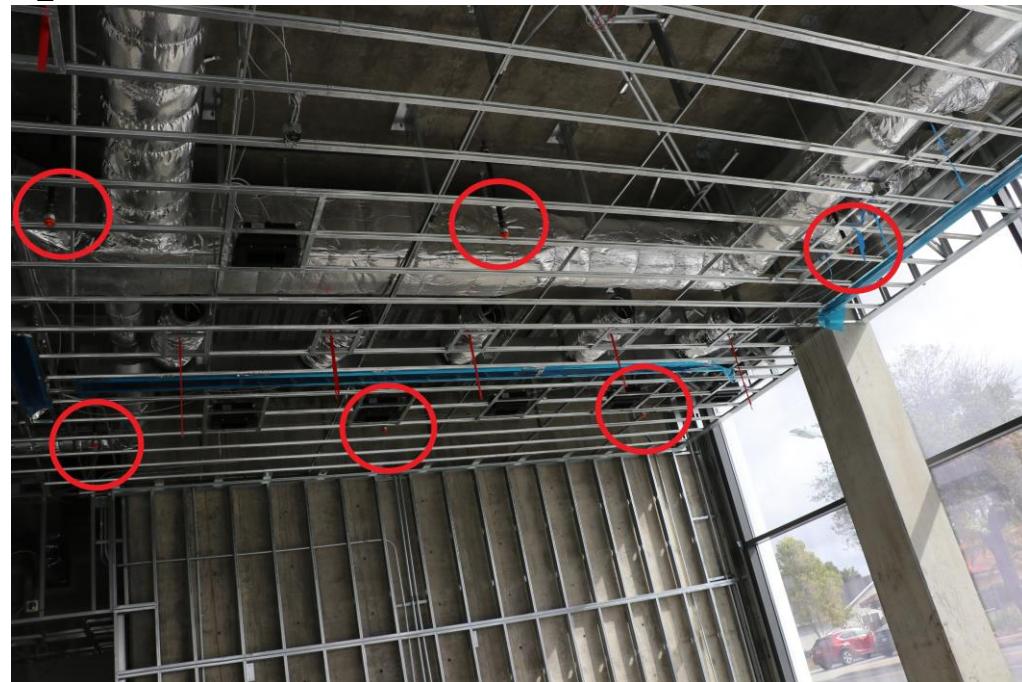
1		
2	3	The fire sprinkler system is not currently capable of providing life-safety protection for the Project.
3		The water supply lines and the automatic sprinklers have all been installed the Hotel, as confirmed for each of the floors I visited on my March 25 walk-through (floors 1, 2, 4 and 7). However, the protective covers for the sprinklers are still in place because the ceiling drywall and finish have yet to be installed. See photos below.
4		
5		
6

1 **IMG_5090 – Second Floor Hallway**
2
3
4
5
6
7
8
9
10
11
12

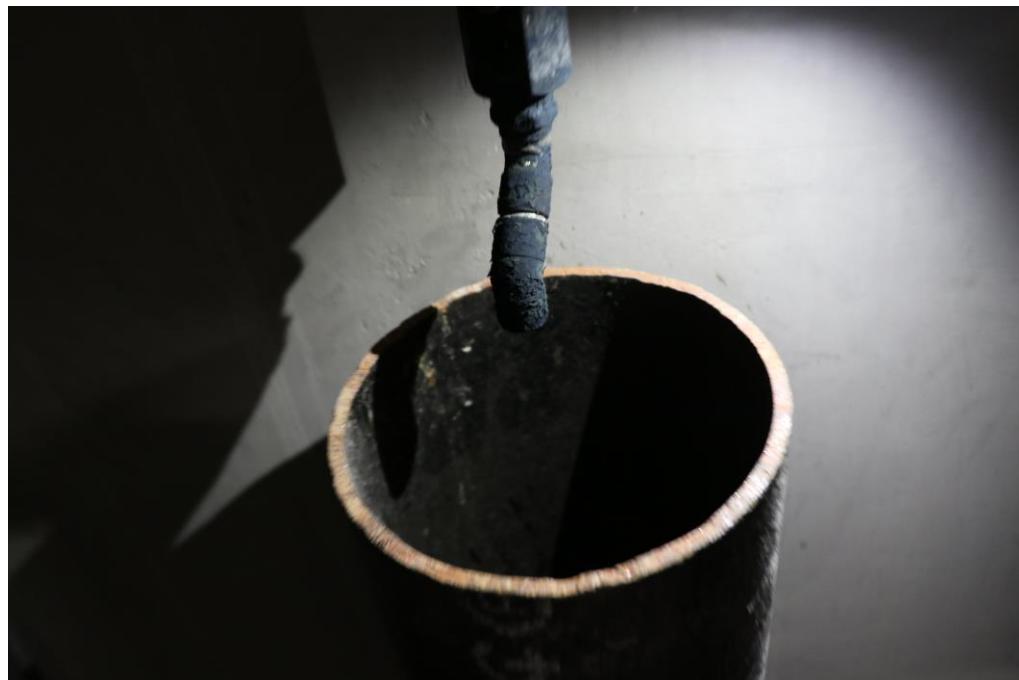
No.	Shady Bird's Allegation	Debtor's Response
6	Completed business finishes are not being protected and are exposed to waste or damage.	It is unclear what "completed business finishes" Shady Bird is referring to. There are some HVAC materials that have yet to be installed which are currently stored on the roof, but none of those materials are being wasted or damaged. Based on my March 25 walk-through, there appears to be no other "completed business finishes."
7	A potentially hazardous situation may exist if the building sewer system is not connected to the public system.	The building sewer system is connected to the public system, but unused drains can emanate sewer odors since the water that would otherwise drain down the pipes (like the P-traps, those U-shaped pipes under drains) to seal against odors from the sewer line would evaporate. As part of my maintenance duties, my crew and I regularly flushed/drained/hosed water down these drains to maintain the water seal. Based on my March 25 walk-through, it appears that the Receiver has not performed proper maintenance by flushing toilets or filling the P-traps, which has resulted in odors from the sewer line to come out. The Receiver's staff acknowledged during my March 25 walk-through that the odor was likely from the toilet, shower and sink drains losing their water seal, and indicated they were unaware of any other chemical/hazardous reasons for the odor. See photos below.

18 **IMG 5011 – toilet on Seventh Floor**

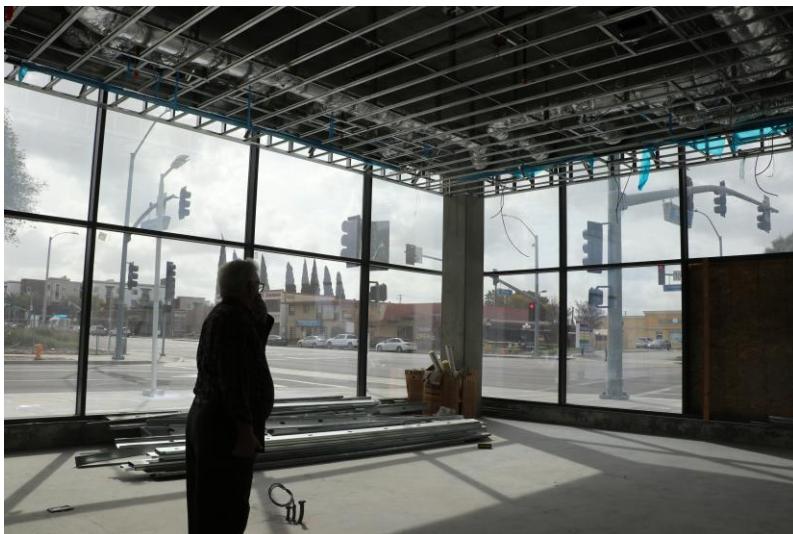
1
2
3
4
5
6
7
8
9
10 **IMG 5101**

No.	Shady Bird's Allegation	Debtor's Response
10	The Debtor's failure to take reasonable measures to maintain, protect, and secure the project under the operative deed of trust.	This appears to be a "catch all" reference to all of the items discussed above, but my March 25 walk-through indicated nothing out of the ordinary. The Debtor and M+D took reasonable measures to maintain, protect and secure the Hotel before the Receiver took possession, but it appears that the Receiver has not continued such measures.
11	The Debtor's failure to prevent the project from becoming vandalized, damaged, destroyed, and deteriorated.	While the Debtor was in possession, there was an incident where a vandal broke a storefront glass window facing Orangethorpe Avenue, which my crew repaired. After the Receiver took possession, there was another incident where a vandal broke the storefront windows facing both Orangethorpe Avenue and Brenner, which resulted in the Receiver installing plywood to cover the windows.
